Why use the Delta Sigma?

| Resonic Instruments | Document No: CS – Delta Sigma | |

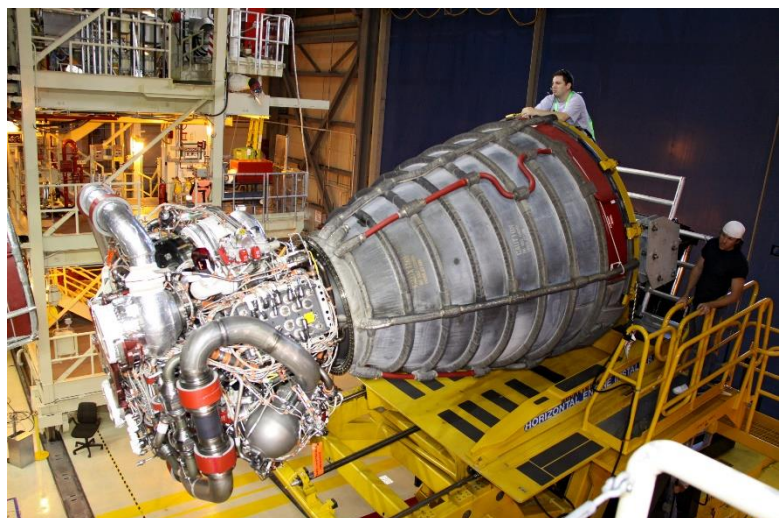
Used on the Space Shuttle

A tensioned bolt on the Space Shuttle liquid hydrogen connection was little more than hand tight after the hydraulic tensioner suffered internal damage and was not able to rotate the nut properly, leaving it little more than hand tight. Each time fuelling began, hydrogen gas was detected and the processed had to be stopped. Finally, after several attempts with the same results, the shuttle had to be returned to the Vehicle Assembly Building and the launch was delayed by weeks. The costs of these delays and testing to discover that the bolt was loose due to a damaged tensioner were in the millions of dollars. Had the leak not been detected, the results would have been catastrophic.

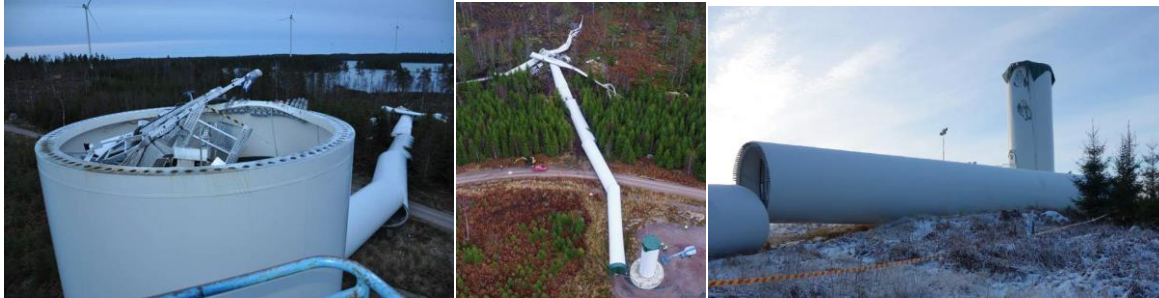
SUMMARY IN ENGLISH

“Lemnhult wind farm is located about 20 kilometers south of the city of Vetlanda in Jönköping County. The wind farm consisted of 32 wind turbines, of the same type and height. On 24 December 2015, one of the turbines collapsed. The wind turbine that fell, tower 15, was 129 meters tall, and had a turbine diameter of 112 meters. The wind turbine had been in operation for almost three years.”

«The cause of the fatigue in the bolts was that the pre-tension force in the joint was too low.»

“Settlement had not been taken into account, either in the joint or in the softer materials, which always affect the pre-tension force.”

A current example of a total failure to an asset as a result of not using a Delta Sigma was just published from the Swedish accident investigation authority, and is highlighted below:
